Water Compliance Inspection Report

***NPDES
Inspection Report***

***Sytsma Brothers Dairy
Bellingham, WA***

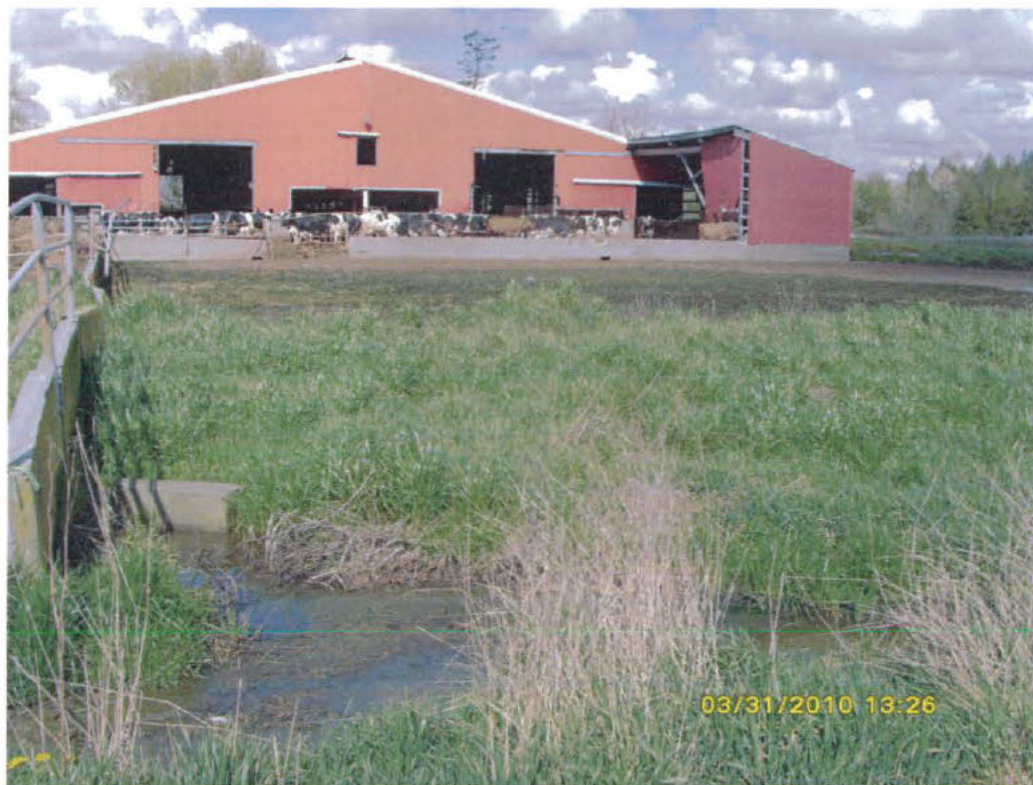
A. Although I did not see a waste discharge at the time of inspection I observed high levels of waste in both of the storage lagoons. See Attachment A, Photo 1, 2, and 3. Each lagoon appeared to be full. Lagoon 1 had approximately 2 inches of freeboard. Lagoon 2 had more room for additional waste but the overflow pipe from Lagoon 1 to Lagoon 2 was blocked and not functioning at the time of the inspection. The dike separating the

two lagoons has been cut into to try and allow flow from Lagoon #1 to Lagoon #2, but that was not flowing at the time of the inspection. The nearest waterway, an unnamed ditch which runs into Ten Mile Creek is about 75ft from the lagoons.

Photo 1. Looking west at the first of two lagoons with the confinement area behind it. Note the level of manure and the presence of vegetation growing on the manure in the lagoon.

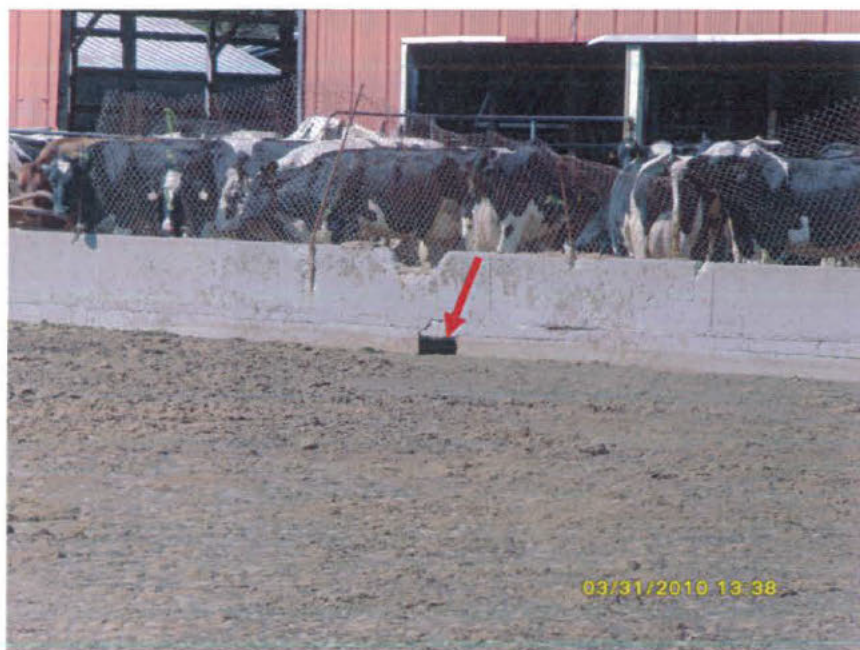
Photo 2. This is a close up of the first lagoon. The arrow points to one of the slots that the manure from the confinement area is scraped through to the lagoon.

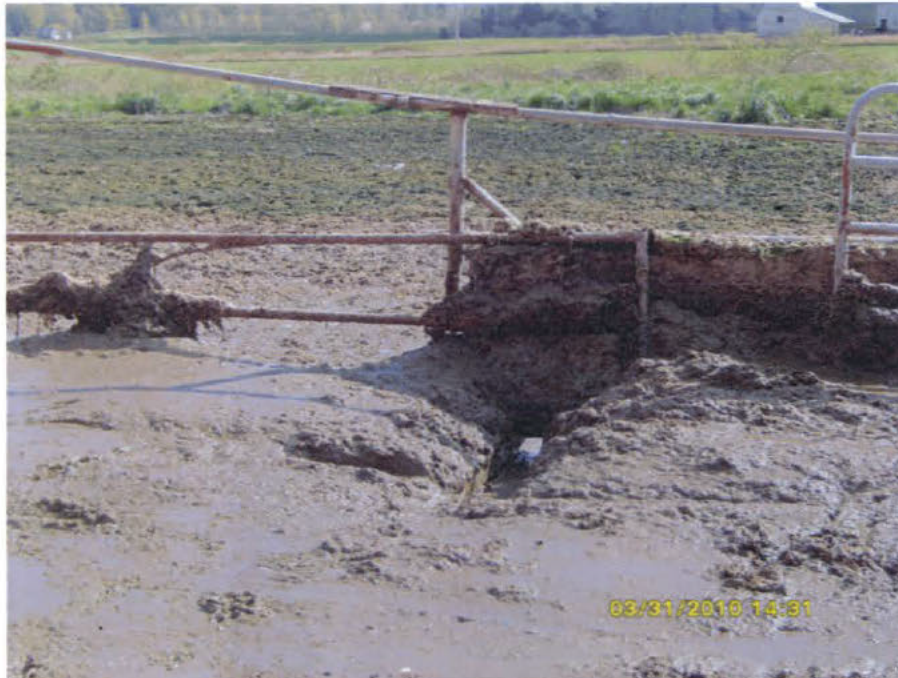
Photo 3. This is a picture of a slot from the confinement area looking towards the first lagoon in Photos 1 and 2. Note the level in the lagoon directly on the other side of the fence.

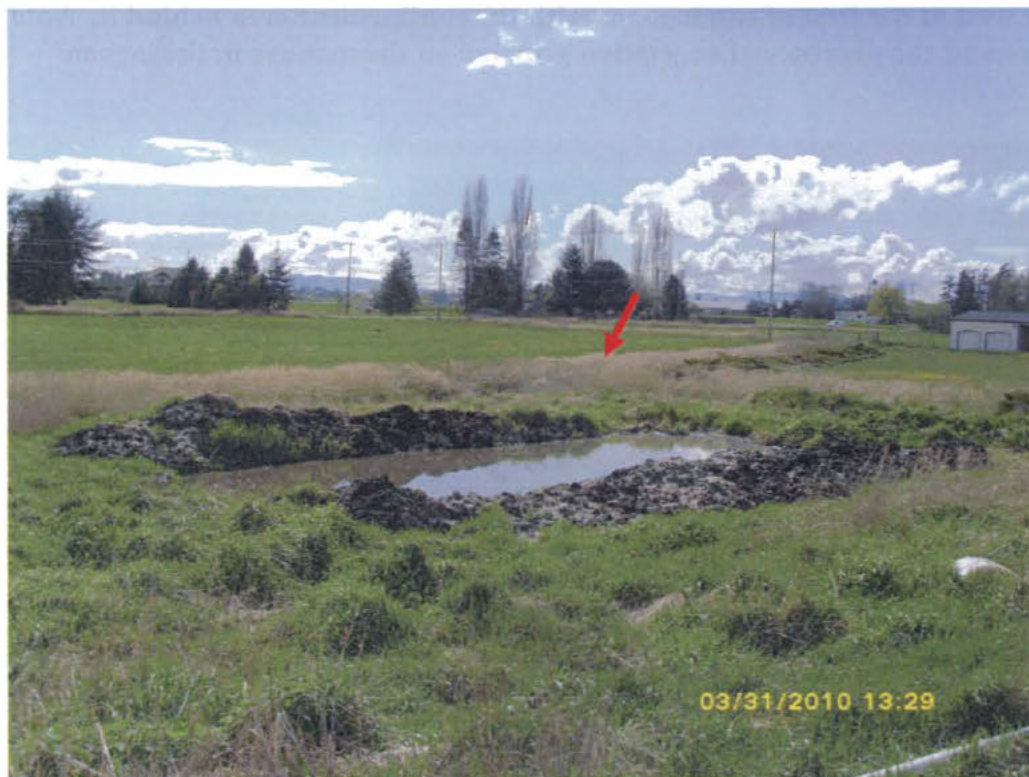
B. According to Fred, more waste storage was needed so they dug a pit near the unnamed ditch (see photo 4). This pit is approximately 35 feet from the unnamed ditch. Water from one of the silage storage areas (see photos 5 and 6) is pumped to the pit as needed. The water was not discharging from the pit at the time of the inspection, but the water level was high and there is potential for water stored in the pit to discharge to the nearby ditch.

Photo 4. This is a pit that the Sytsma's pump silage leachate from the silage storage area in Photo 5 into. The arrow indicates the unnamed ditch just behind the pit.

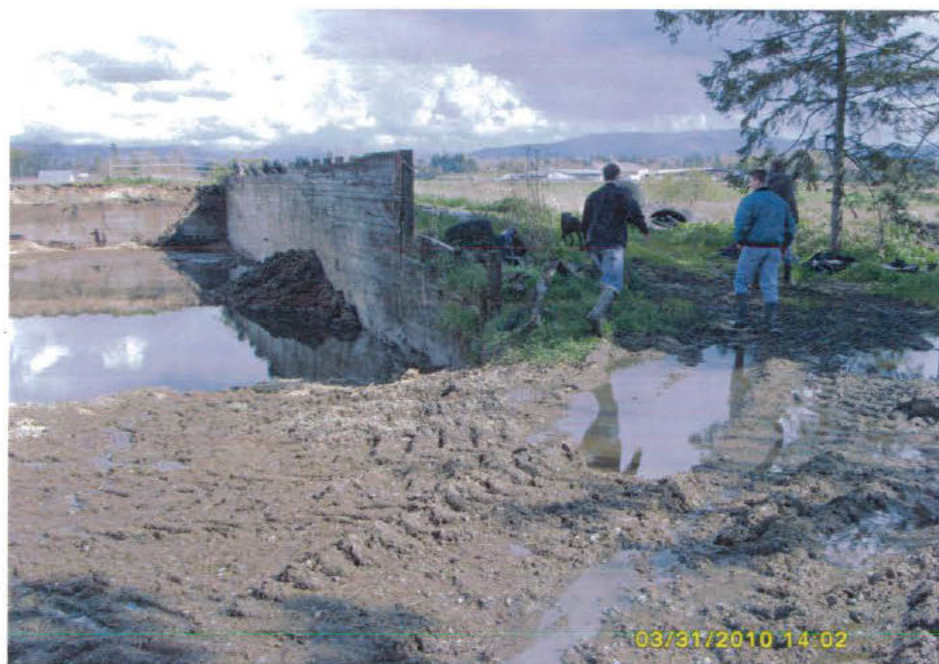
Photo 5. One of the silage storage areas. The water in this area is pumped to the pit in Photo 4, which is located on the other side of the tree in this photo.

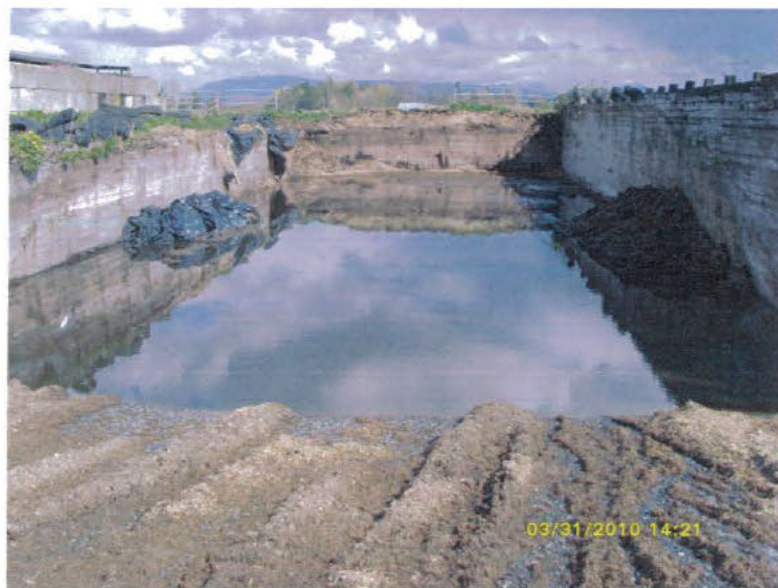
Photo 6. Another view of the silage storage area in Photo 5.

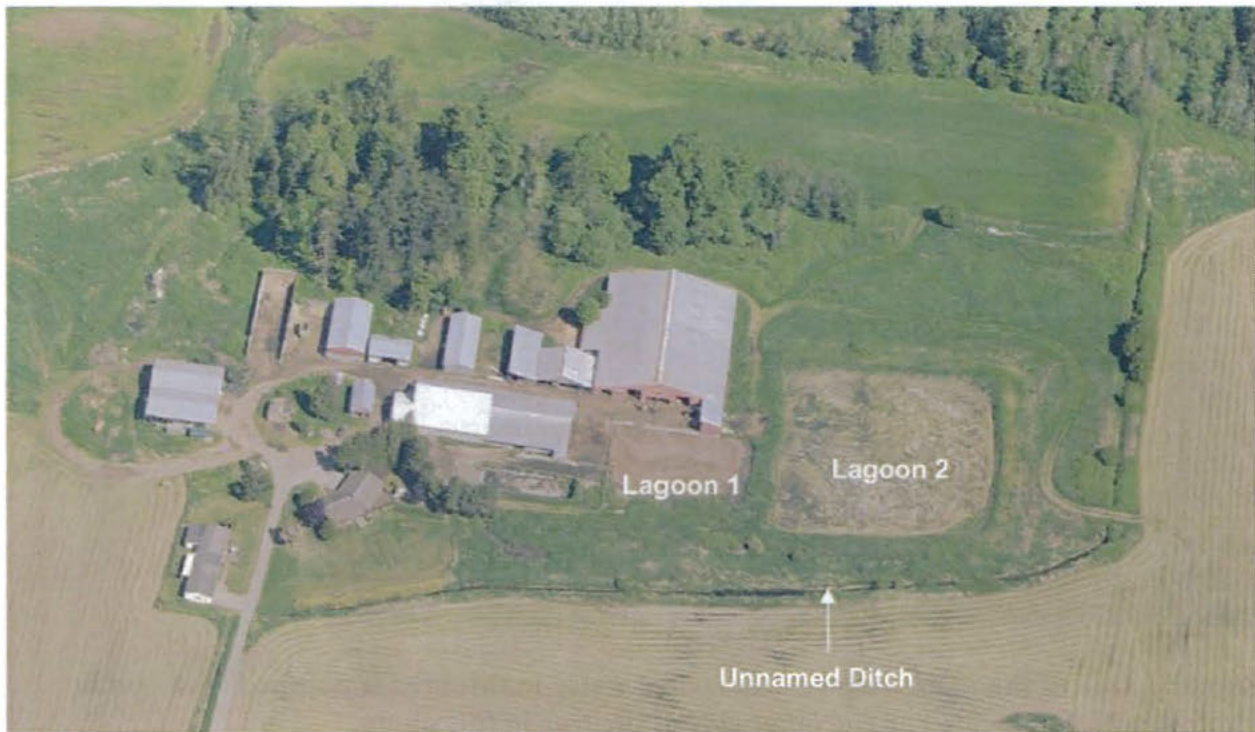
The nearest waterway to the Sytsma Dairy Farm property is an unnamed ditch approximately 75 ft from lagoon 2 (See photo 7, which is an aerial view of the Dairy). The unnamed ditch drains into Ten Mile Creek.

Photo 7. An aerial view of the Dairy.
